K/CR-734/DEL

CARBIDE AND CARBON CHEMICALS COMPANY
K-25 Plant

Subject: Report of Material Release

Date of Incident: October 6, 1952
Nature of Incident: Ruptured Cold Trap
Location: K-1131 Feed Plant

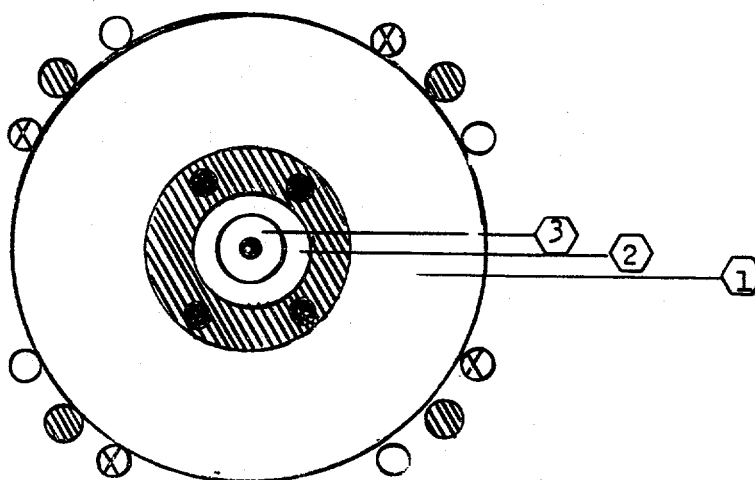
CROSS SECTION VIEW OF COLD TRAP

- (b) The original "triple-pass" design of the cold trap called for heating units inside the trap as shown on the diagram of the cross section of the trap. However, the original vendor of these heating units has encountered difficulty in meeting the specifications so, despite the fact that such units have been on order since November 1951, none have been delivered. As a result of the recent increased use of these heaters caused by their usage in phase II of Feed Plant operations, the plant reserve has been exhausted and in September 1952 it became necessary to devise a substitute heating method which involved doubling the number of heating units placed outside the trap.

6. Any HF which may have been in the trap was not considered to have been a causative factor in this rupture.
 7. The rupture consisted of a 1-1/2" long longitudinal crack under one of the clips holding one of the original calrod heating units close to the trap surface. Although the original specification had required a thermal insulator between the calrod unit and the clip, such insulation had not been applied in this case. Also, the clip was designed to hold the heater approximately 9/16" from the trap surface, but inspection at the time of discovery of the crack indicated that in some way it had been so pinched that the calrod was in contact with the trap shell. The description of the calrod units included a surface temperature specification of about 500°F.
